Note

Copper and Muntz Metal Sheathing: a global update

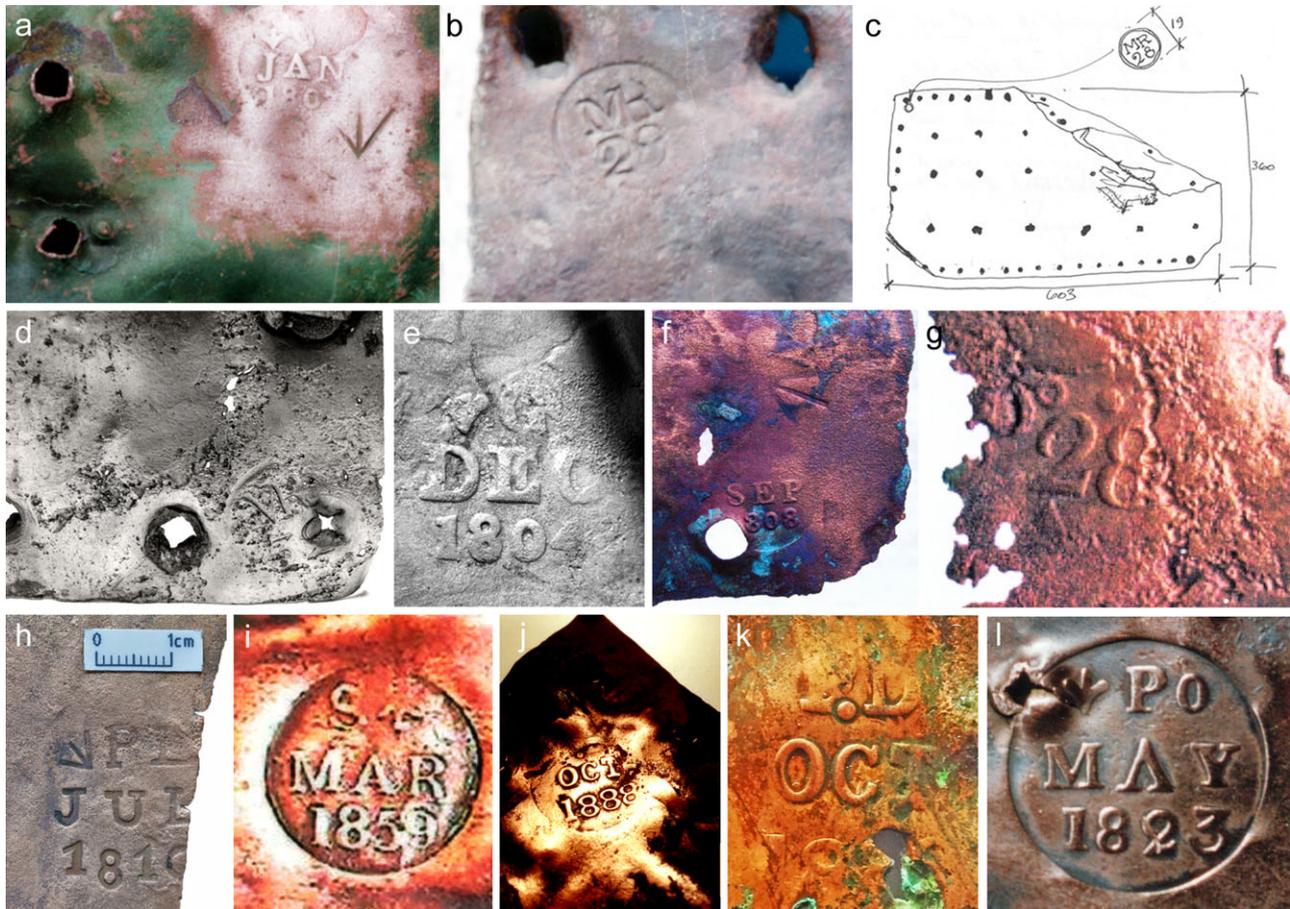
Figure 1. Sheathing marks found on Royal Navy ships HMS *Agamemnon* (1809), HMS *Pomone* (1811), HMS *Sirius* (1810), HMS *Forte* (1856–1906) and HMS *Victory* (1768–present), see Table 1.

In the late 18th century and in the early years of the 19th century, the British Admiralty continued to buy in sheathing from the Mines Royal Company until the Portsmouth Rolling Mill was built 1804–06 (NMM, 1804). At the time, the Admiralty had a large stock of used copper sheathing that needed recycling. Current research found the latest use of Mines Royal copper was on the 64-gun *Agamemnon* wrecked in Maldonado Bay, Uruguay, at the entrance to the River Plate on 16 June 1809, which had been re-coppered at Chatham Dockyard in 'JAN 1807' (Fig. 1a, Table 1) and the sheathing displayed the mark 'MR 28', indicating the use of 28oz per square foot plate (Fig. 1b-c).

The 38-gun *Pomone* wrecked at the Needles, Isle of Wight, 14 October 1811, bore a similar Mines Royal Company sheathing mark of 'MR 32' (Fig. 1d). It is assumed that *Pomone* was coppered with sheets supplied by Chatham Dockyard due to the presence of the stamp 'C' above 'DEC 1804' (Fig. 1e). The ship was built at Brindley's Yard at Frindsbury, exactly opposite the Royal Yard on the other side of the Medway River. Possibly Brindley subcontracted the task to the Royal Dockyard since the sheathing displays the Chatham mark. *Pomone* was launched on 17 January 1805 (Tomalin *et al.*, 2000).

The 36-gun *Sirius* was destroyed by fire at Mauritius to avoid capture by the French on 25 August 1810. Copper sheathing recovered from the wreck had 'C' for Chatham above 'SEP 1808' (Fig. 1f). It appears that Chatham Dockyard used copper supplied by Portsmouth Rolling Mill marked 'P° 28' (Fig. 1g).

HMS *Forte*, a 3456-ton, screw-powered, 51-gun frigate built at Deptford and launched 29 May 1858, had been coppered and marked 'S' above 'MAR 1859', which indicates that the ship went downstream to Sheerness Dockyard for this task (Fig. 1i). HMS *Forte's*

since it trapped rainwater, causing the hull timbers to rot. The examination of the removed copper revealed 21 different manufacturers' and Admiralty inspectors' marks (Bingeman *et al.*, 2000). The majority of the sheathing was dated 'OCT 1888' (Fig. 1j) and a few marked 'P.D OCT 1888' (Fig. 1k), the date of *Victory's* last major re-sheathing. There was a single earlier date of 'MAY 1823' (Fig. 1l).

This paper increases the number of known dockyards’ sheathing marks, by introducing countermarked coins. It now seems clear that dockyard workers used these copper-sheathing franking punches to make mementos. The following examples are of interest because they confirm that Deptford (Fig. 3a-b) and Woolwich (Fig. 3c) also sheathed ships. Portsmouth Dockyard used ‘P’, then ‘Po’ and later ‘P. D’, first seen on coin countermarks for 1876 (Fig. 3h) and when re-sheathing *Victory* in October 1888 (Fig. 1j-k).

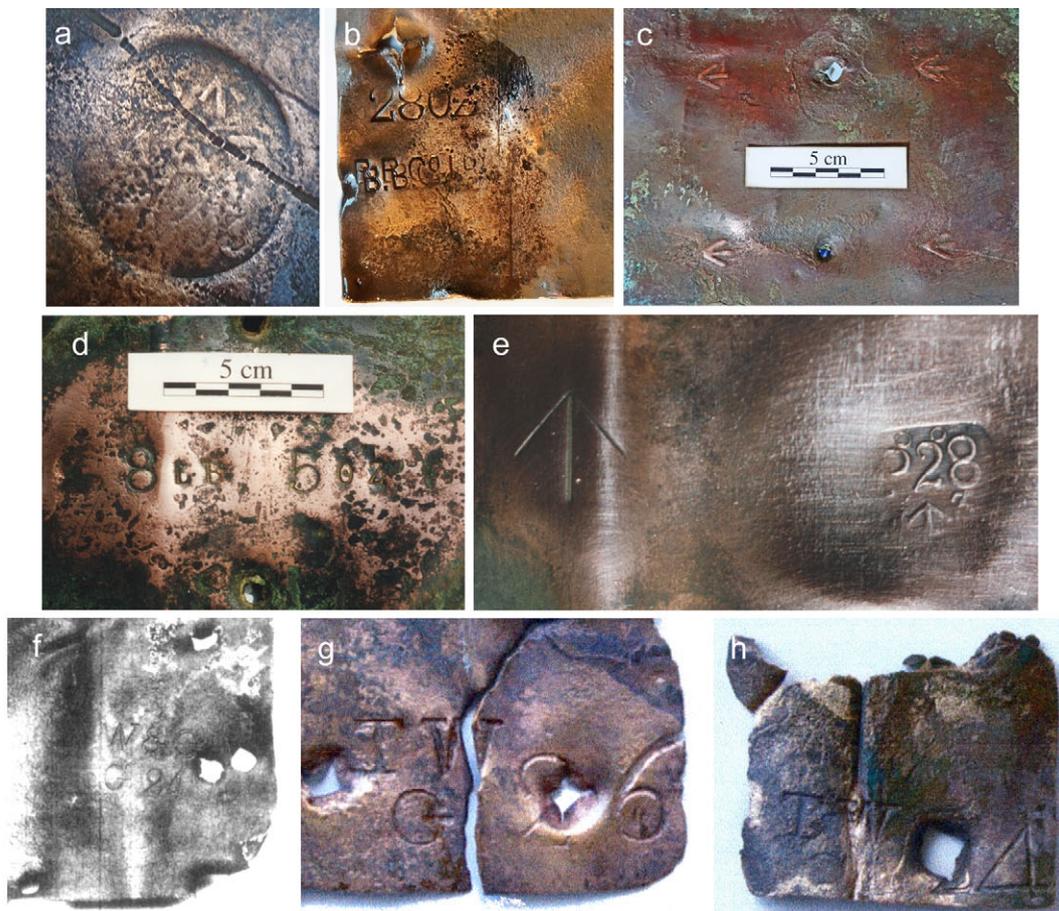
Figure 2. Sheathing marks from HMS *Gannet*, HMS *Victory*, *Cleopatra's Barge* (1817–1824), and the lugger *Coureur* (1818–1821), see Table 2.

within the stamp (Fig. 3j), subsequent ones had an additional figure (Figs. 2e and 3k). The reason for the ‘3’ and ‘4’ set within the stamp is not known, but perhaps represents a batch number.

What does the letter ‘G’ in ‘G 24’ mean, as seen stamped on the *Cleopatra’s Barge’s* copper (Fig. 2f)? Firstly, the Imperial Standard & Old Birmingham Wire Gauge thickness measured 0.022 inches (0.5588mm). This does not match the *Cleopatra’s Barge’s* copper thickness marked as ‘G 24’. The measurement of ten sample thicknesses closely clustered around 0.032 inches (0.8128mm), the same thickness found on 24oz per square foot copper plate (CDA, 1935: 68). One can

Welsh Anglesey copper was considered superior to the Cornish copper since the latter contained bismuth, an impurity that created a crystalline structure causing embrittlement during rolling. This problem is rather borne out by the visible surface cracks in Thomas Williams’s copper (Fig. 2g-h).

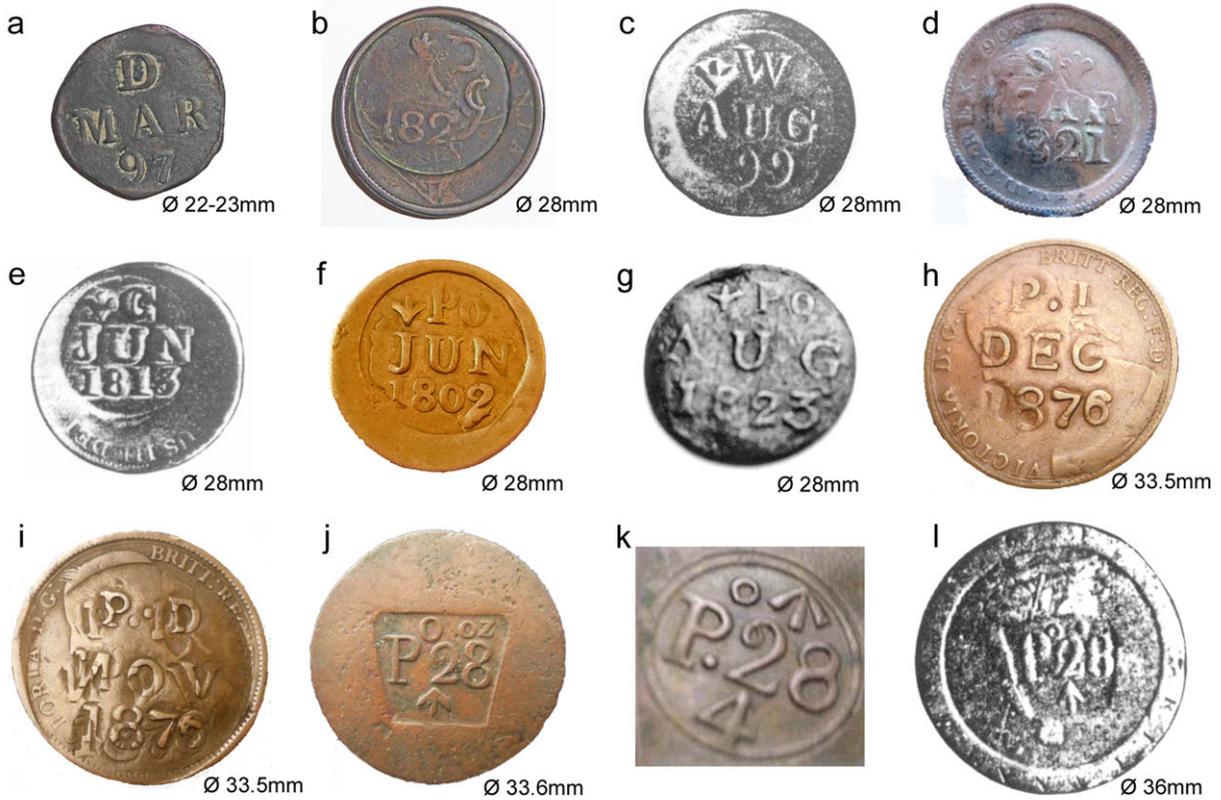
Figure 3. Privately countermarked coins, see Table 3.

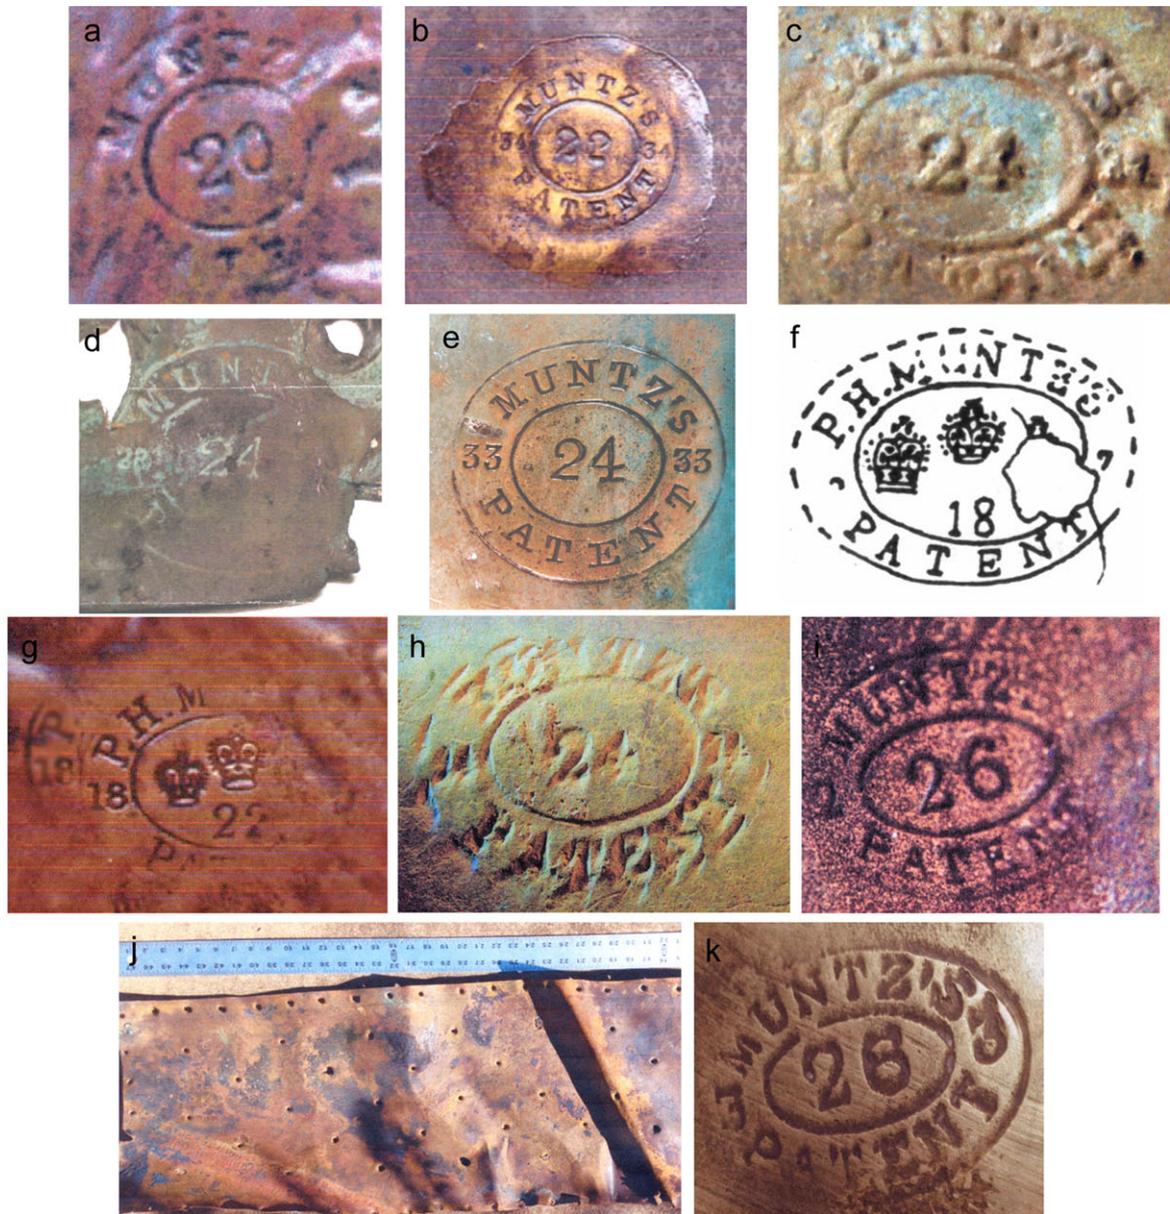
Figure 4. Examples of Muntz metal marks, see Table 4.

'Eighteen vessels in Her Majesty's service have been sheathed with Muntz's yellow metal, and from reports it has appeared to wear well' (Hay, 1863: 92). The central figures 18, 20, 22, 24 and 26 are confidently assumed to be their weight in ounces per square foot of metal (Fig. 4, Table 4). The Muntz seal rim numbers remain a mystery; they are assumed to be some internal company coding. The numbers found were: 2, 3, 7, 21, 24, 28, 33, 34, 41, 44 and 74. Most of these sheathing pieces have been recovered from the North-Sea-facing Dutch coast on Terschelling and Texel islands without any provenance to decode their meaning. Most shards are held at Terschelling in the 'Behouden Huys' Museum and Wreck Museum (Het Wrakkenmuseum) (pers. comm., N. Brinck, 1 June 2017).

The 26oz example (Fig. 4i) comes from the Australian ship *Petrel* (1847–1853), a 195-ton barque built in Tasmania and wrecked off Hope Beach, Tasmania (McCarthy and Stanbury, 2003). The vessel's short life suggests that this could be its original sheathing. The *Snow Squall* (1851–1864) was a 742-ton clipper ship abandoned in 1864 at Stanley in the

Falkland Islands. Its last sheathing was carried out in 1862 during a repair at Singapore in 1863 (*The Strait Times*, 19 May 1863: 2, 5, 16). The ship's bow section has been rescued and is now on display in the Maine Maritime Museum in Bath, Maine, USA. Analysis of the Muntz metal (Fig. 4h) showed sample averages of Cu 64½%, Zn 37½% (Carlson *et al.*, 2010: 78).

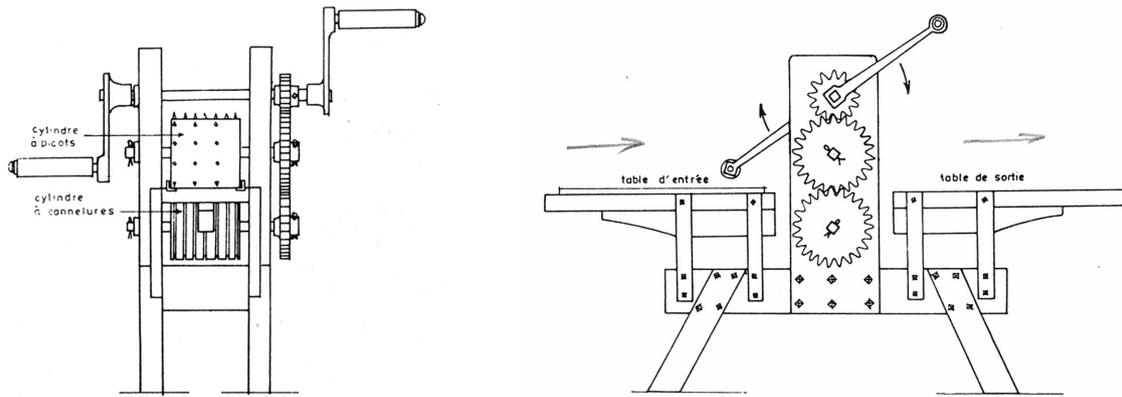
Figure 5. Drawings by J. le Bot in his paper ‘Le doublage en cuivre des terre-neuvas’ (published in *Le Petit Perroquet* 21, 1977: 43).

An unidentified wreck at Cape Remain, South Carolina, USA, was coppered with typical Muntz 26oz 14 × 48 inches (1.219 × 0.3556m) plate that has been subject to dezincification while static on the seabed, which has given it the appearance of copper rather than a copper-zinc brass (Fig. 4j) (sample provided by Dr E. Lee Spence). The plate was applied with great care using copper-nail holes evenly spaced, with edge nails set 2 inches (50.8mm) apart and 4 inches (101.6mm) apart for the central securing nails. It is likely that these holes were pre-punched by a machine similar to the French system (le Bot, 1977: 43) (Fig. 5).

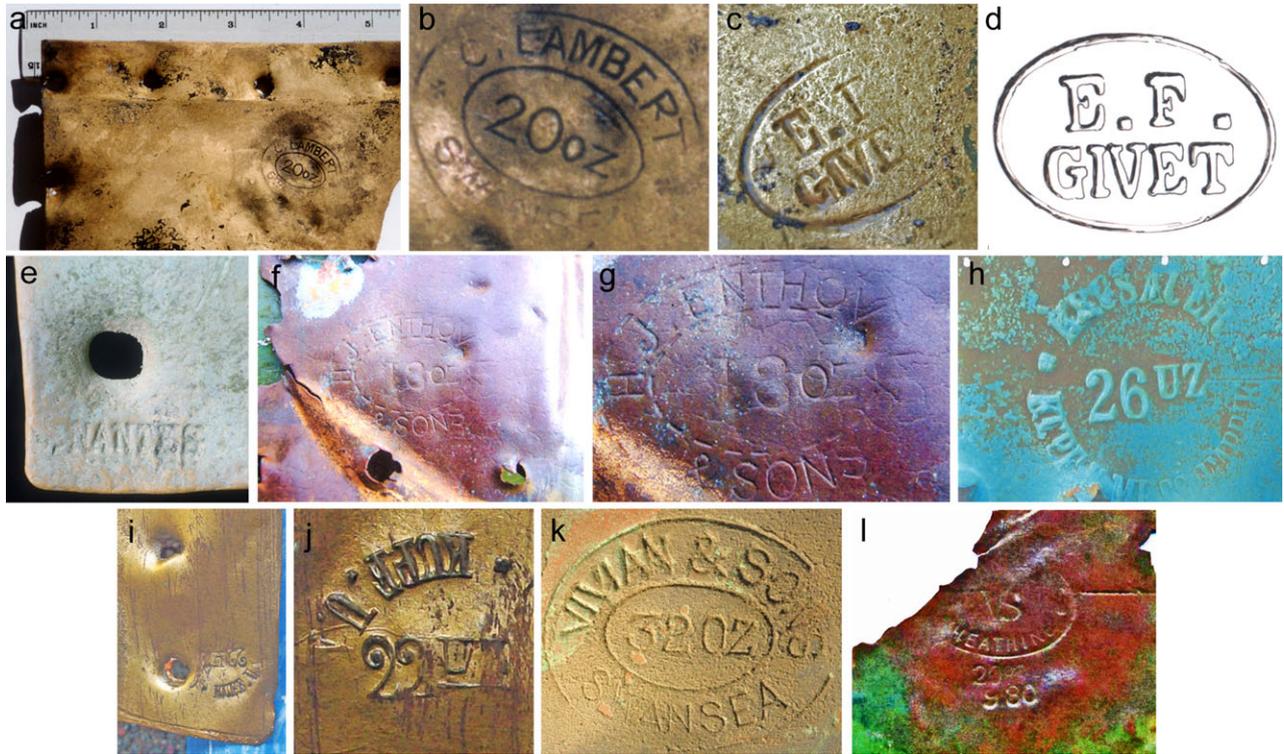
Figure 6. Other manufacturers’ marks, see Table 5.

A piece of brass sheathing manufactured by 'C. LAMBERT – SWANSEA' has been recovered from Turtle Rocks near Beacon K in the Florida Keys National Marine Sanctuary (Fig. 6a-b, Table 5). Its yellow colour confirms that it is similar to Muntz metal. Charles Lambert & Co. (1852–1902) could have been manufacturing ships' sheathing with the approval of George Frederick Muntz who had granted

A recent discovery of a complete 48 × 14 inches (1.219 × 0.356m) plate of Muntz-type yellow metal stamped ‘E. F. GIVET’ was found by divers in the North Sea off Den Helder (Fig. 6c-d). This brass factory was owned by the Estevan Frères (Brothers) between 1835 and 1878, who used the name ‘E. F.’ only from 1868 (pers. comm. Nico Brinck 27 March 2017). ‘GIVET’ is a district in the Ardennes on the Belgian-French border.

Wreck G at Galle, Sri Lanka, probably the 1100-ton Dutch East Indiaman *Geinwens* (1765–1776), had a copper/zinc alloy (Cu 65% Zn 35%) sheet stamped with the place name 'NANTES' (van Duivenvoorde, 2015: 8) (Fig. 6e). *The London Encyclopædia* published in 1829 reported that the city of Nantes had 'brass-foundries' and a shipyard capable of handling vessels up to 1000 tons. From the mid 19th century a suitable brass for sheathing ships would be a 65:35 copper-zinc alloy, an improvement on Nantes's general coppering tradition (L.E., 1829: 371). One of these foundries could have operated a rolling mill to supply ships' sheathing, hence the NANTES trademark.

'18oz' at the centre (Fig. 6f-g), Enthoven's must have operated a brass rolling mill producing Muntz-type ships' sheathing. During World War 2 its products were used by the Royal Aircraft Establishment, and more recently they became lead smelters and refiners, specializing in products of lead, tin, solders and rigid plastic pipes.

copper production. In 1841 Vivian's took over the abandoned Birmingham copper works (Hughes and Reynolds, 1992: 33) to start the Morrison zinc smelter works. In the following year, since zinc was a major component, they started manufacturing Muntz metal (Grace's Guide). Evidence from another shipwreck found on the island of Texel, Holland shows 'VS' as Vivian's trademark when manufacturing Muntz metal, confirmed by the word 'Vivian' just visible on the stamp rim (Fig. 6l). Below the 'VS' trademark are '20oz' stamps denoting the plate's weight per square foot, as well as '980'. The latter might be a delivery batch number; if records still exist it could identify this unknown wreck. Vivian & Sons copper 28oz sheathing was also used on and removed from HMS *Victory* when re-coppered in 'OCT 1888' (Fig. 1k) (Bingeman *et al.*, 2000: 225, 227). A 'Vivian 32oz' copper mark was found among *Victory's* sheathing sold in 2000 (pers. comm. Vin Callcut 9 April 2018) (Fig. 6k).

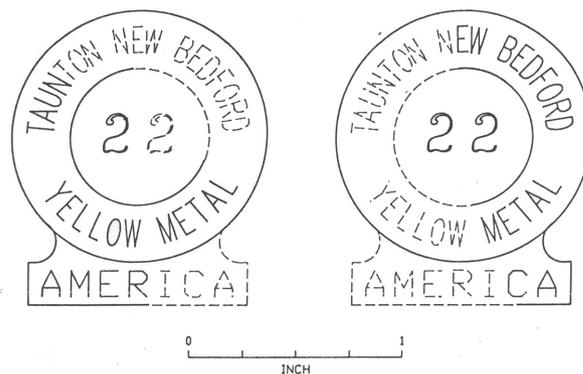
Figure 7. Drawing of a 22oz sheathing mark recovered from the wreck of the *General Comstock* (James *et al.*, 1991: 86).
